FULL RESERVE STUDY

Brighton Lakes Community Development District

Kissimmee, Florida November 29, 2018

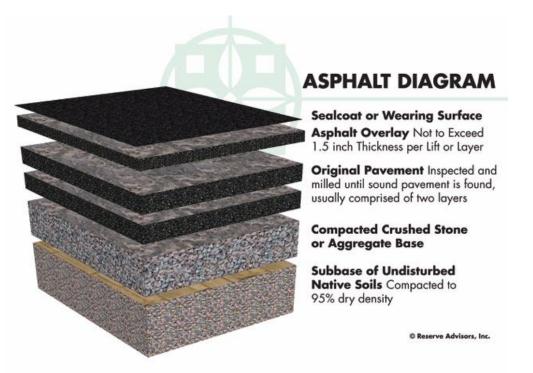
Component Detail Notes: The initial installation of asphalt uses at least two lifts, or two separate applications of asphalt, over the base course. The first lift is the binder course. The second lift is the wearing course. The wearing course comprises a finer aggregate for a smoother more watertight finish. The following diagram depicts the typical components although it may not reflect the actual configuration at Brighton Lakes:

The manner of repaving is either a mill and overlay or total replacement. A mill and overlay is a method of repaving where cracked, worn and failed pavement is mechanically removed or milled until sound pavement is found. A new layer of asphalt is overlaid atop the remaining base course of pavement. Total replacement includes

the removal of all existing asphalt down to the base course of aggregate and native soil followed by the application of two or more new lifts of asphalt. We recommend mill and overlayment on asphalt pavement that exhibits normal deterioration and wear. We recommend total replacement of asphalt pavement that exhibits severe deterioration, inadequate drainage, pavement that has been overlaid multiple times in the past or where the configuration makes overlayment not possible. Based on the apparent visual condition and configuration of the asphalt pavement, we recommend the mill and overlay method of repaving at Brighton Lakes.

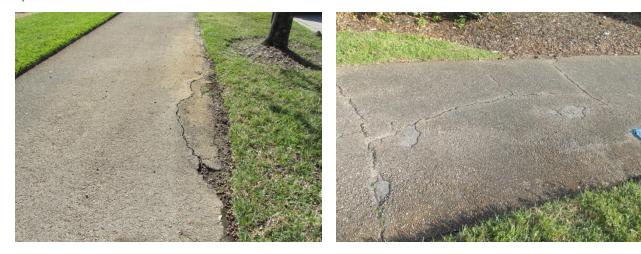
Condition: Good to fair overall with surface deterioration, and edge and block cracks evident

Asphalt walking path with surface deterioration

Asphalt pavement walkway with edge cracks

Asphalt pavement walkway with block cracks

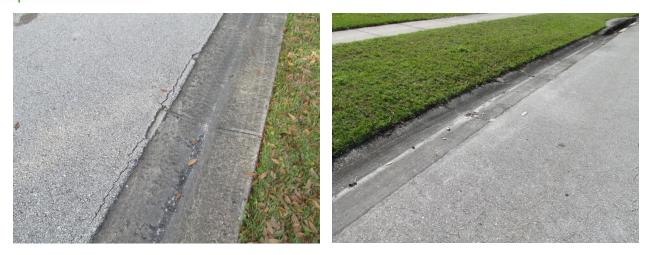
Condition: Good to fair overall with cracks evident

Typical concrete gutter

Concrete gutter with cracks

Expenditure Detail Notes: Expenditure timing and costs are depicted in the **Reserve Expenditures** table in Section 3. We estimate that up to 13,080 linear feet of curbs and gutters, or fifteen percent (15%) of the total, will require replacement during the next 30 years.

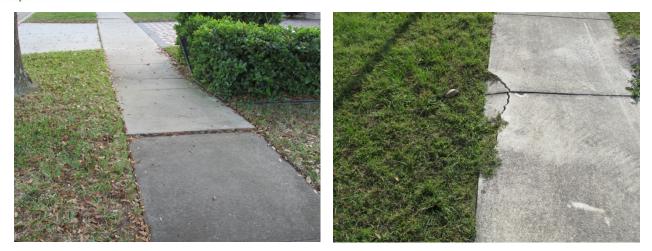
Condition: Good to fair overall with cracks and trip hazards evident

Concrete sidewalk with trip hazard

Concrete sidewalk with cracks

Expenditure Detail Notes: Expenditure timing and costs are depicted in the **Reserve Expenditures** table in Section 3. We estimate that up to 81,685 square feet of concrete sidewalks, or twenty-five percent (25%) of the total, will require replacement during the next 30 years.

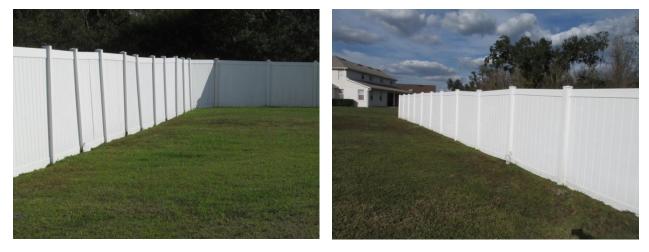
Condition: Good overall

Vinyl fence

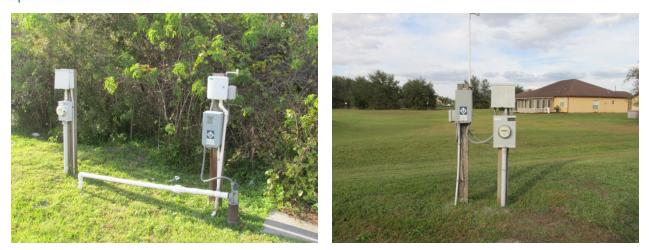
History: Three pumps were replaced in the last few years. The remaining two pumps are reportedly original.

Condition: Reported satisfactory

Irrigation pump

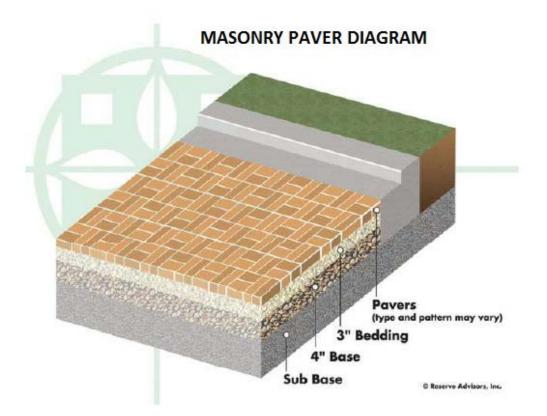
Component Detail Notes: The following diagram depicts the typical components of a masonry paver system although it may not reflect the actual configuration at Brighton Lakes:

Expenditure Detail Notes: Expenditure timing and costs are depicted in the **Reserve Expenditures** table in Section 3. We suggest the Association conduct interim resetting and replacement of minor areas of pavers as normal maintenance, funded from the operating budget.

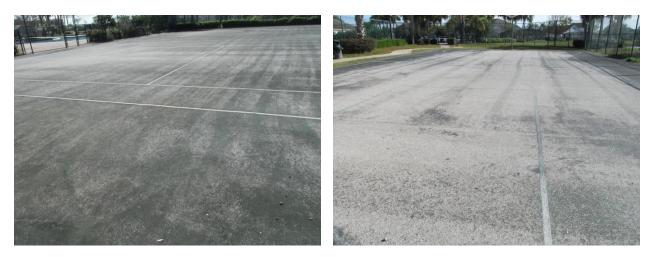
Condition: The color coat is worn away

Tennis court color coat

Basketball color coat

Component Detail Notes: Prior to the application of the color coat, the District should require the contractor to rout and fill all cracks with hot emulsion. This deters water infiltration and further deterioration of the asphalt playing surface.

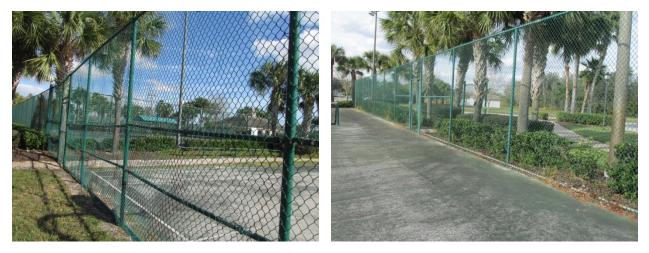
Condition: Good to fair overall

Basketball court fence

Tennis court fence

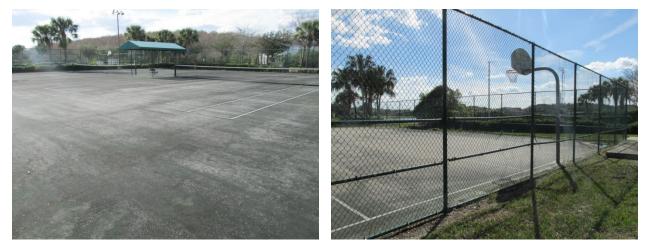
Condition: Good overall with isolated hairline cracks at edges

Overview of tennis court

Overview of basketball court

Hairline cracks evident

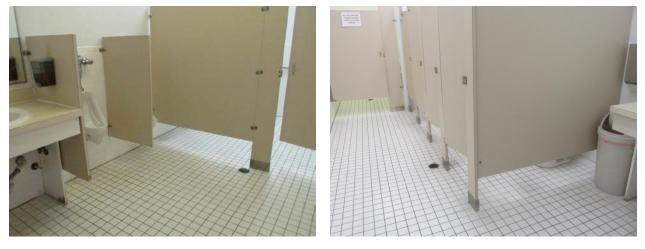
Condition: Fair overall with partition wear evident

Men's rest room

Women's rest room

Partition wear evident

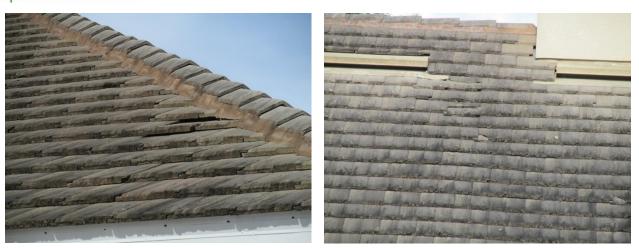
Condition: Good to fair condition with loose and broken tiles evident

Concrete tile roof with loose tiles

Concrete tile roof with broken tiles

Concrete tile roof with broken tile

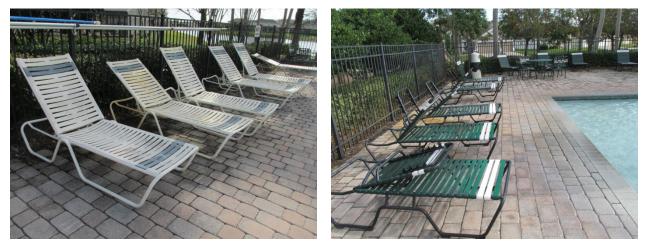
Condition: Good to fair overall

Pool furniture

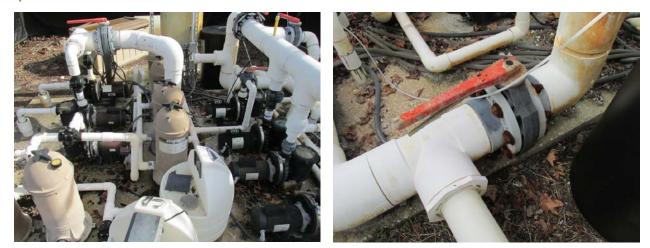
Condition: Reported satisfactory

Mechanical equipment

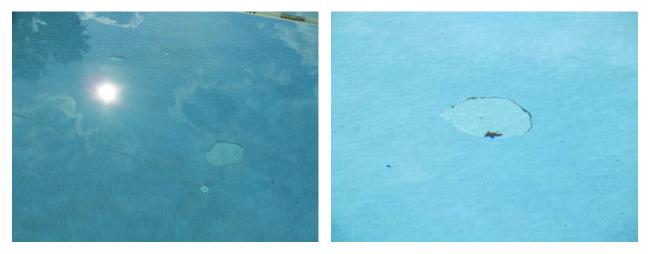
Condition: The tile is in good condition. The plaster finishes are in poor condition with missing plaster evident throughout.

Missing plaster evident
